Study and Restoration of the Zeyrek Camii in Istanbul

Second Report, 2001–2005

ROBERT OUSTERHOUT | ZEYNEP AHUNBAY | METIN AHUNBAY

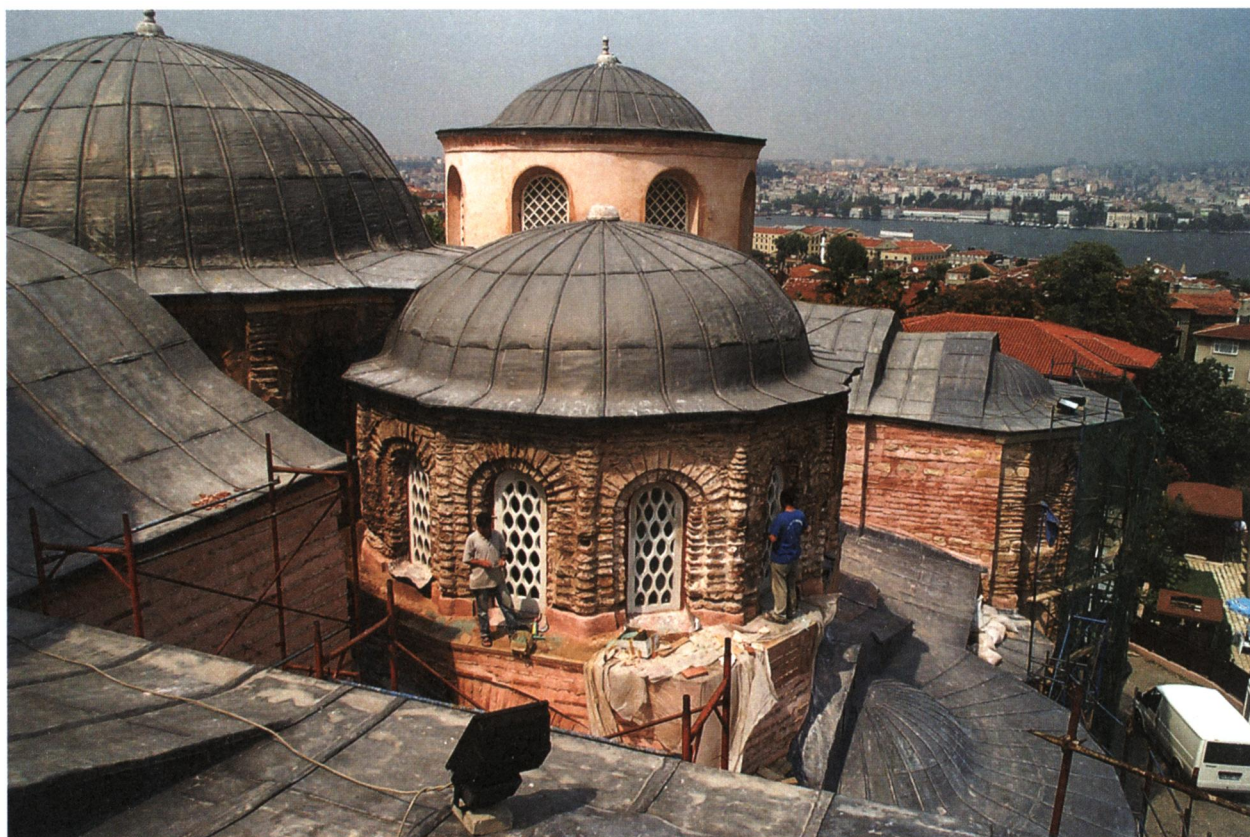
FIG. 3 Zeyrek Camii, east roofs, looking north; workers install glass into new window frames of east central dome (July 2003)

several of the better-preserved original cornice blocks exposed. In addition, the roof level above the southeast corner of the north church had been raised with a dirt-and-rubble fill, and this had to be lowered before a new surface could be established. The base of the east central dome proved to be quite irregular in shape. We completed the work on the eastern vaults and the conches of the apses during the 2002 season (fig. 3).

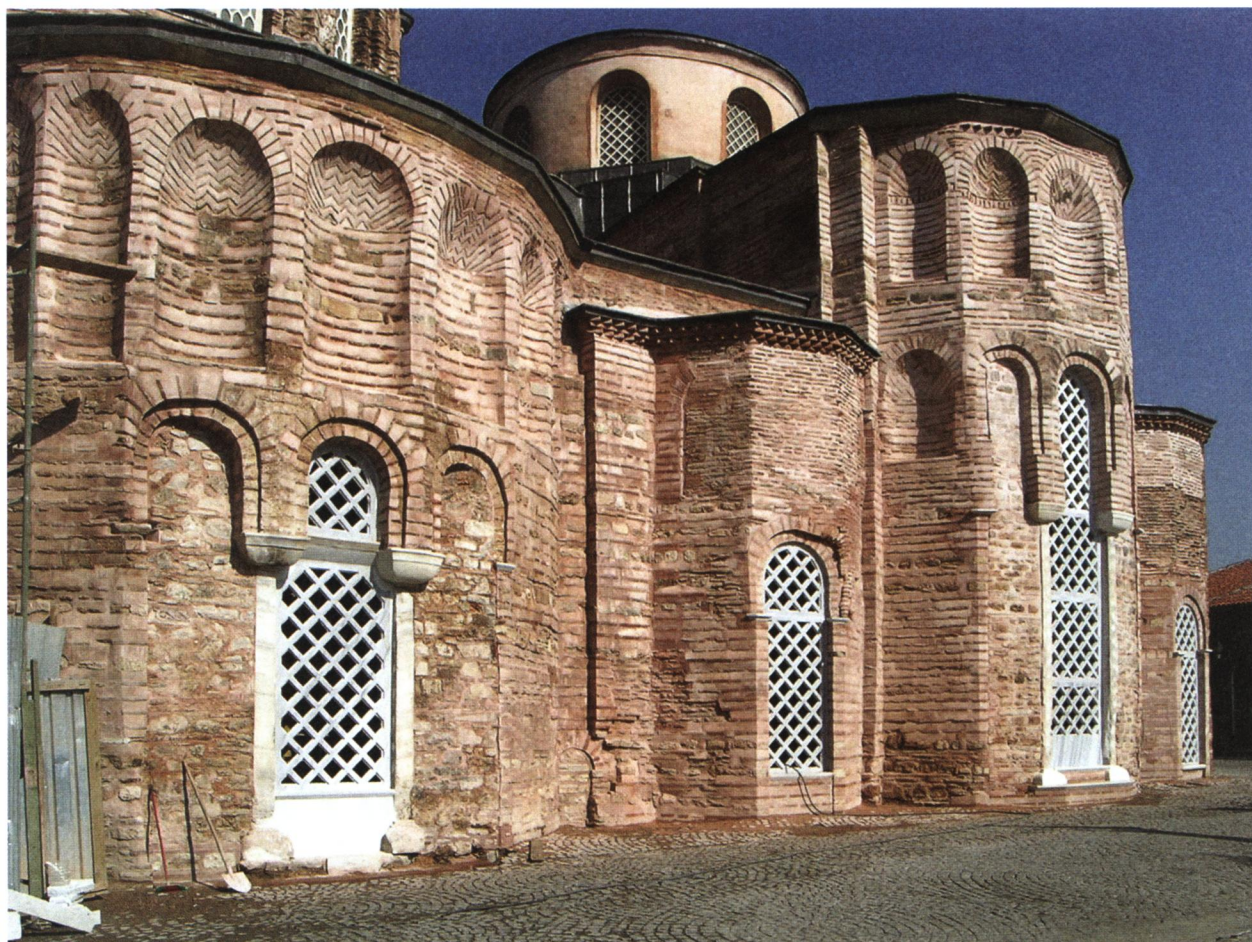
FIG. 5 Zeyrek Camii, detail of east façades of central and north churches after the installation of marble window frames (August 2005)

Our efforts in 2005 concentrated on the east façades of the north and middle churches, completing work begun in 2004, supported by UNESCO (see fig. 5). This provided a dramatic transformation in the outward appearance of the building where it is most visible. The central light of each of the main apse windows was opened to its full height, and the pastophoria windows of the north church were also rebuilt. For these tall windows, 8-cm-thick marble window frames were cut and put in place to increase the stability of the façade. It was not possible to open the lateral lights of the north apse triple window because of their height (over 7 m) and the damage they have suffered. Both mullions exhibited vertical cracks running their entire height, and the bases and capitals had been severely damaged. At some time in the future, it may be possible to open the lateral lights of the middle church triple window, but they were not included in our program for 2005.

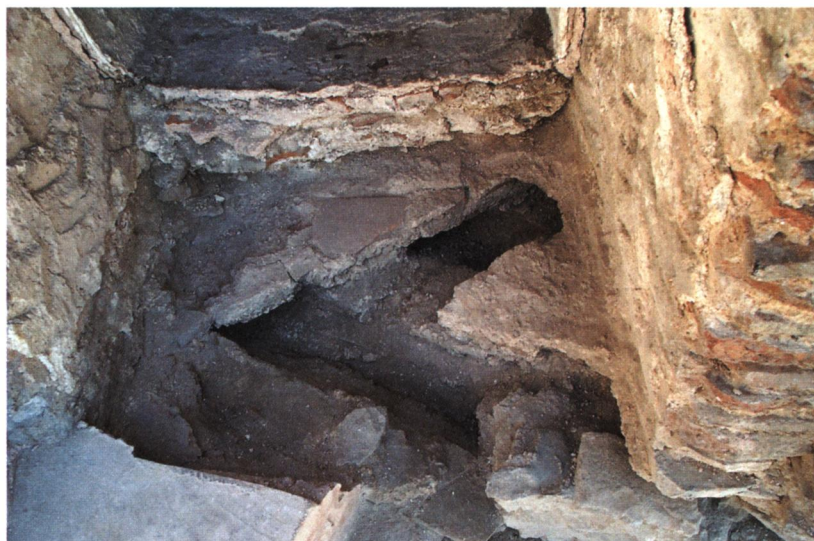
FIG. 7 Zeyrek Camii, window reveal of the west central dome, showing the cavities for reinforcement beams at its base (July 2003)

the masonry, extending around the dome at the base of the drum (fig. 7). During the restoration of this area, we restored the system of wooden reinforcement on the advice of our structural engineer, Professor Feridun Çili.

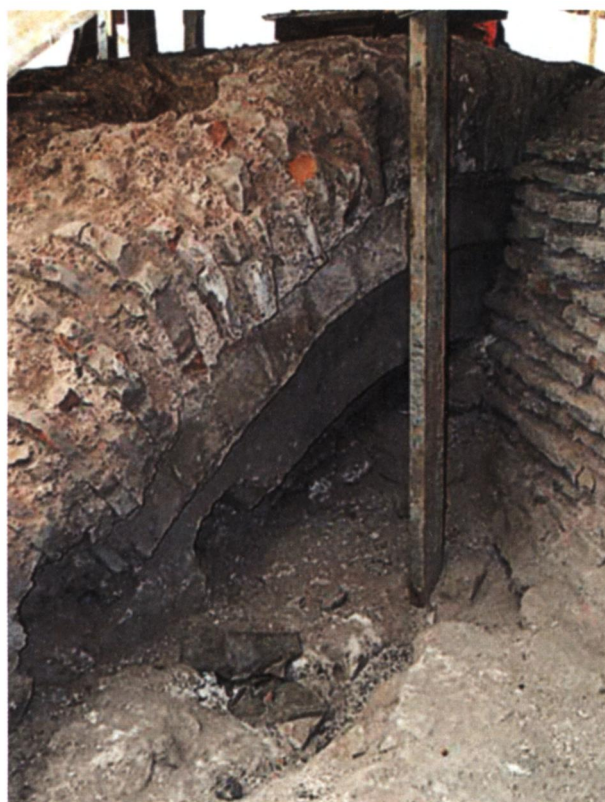
FIG. 8 Zeyrek Camii, the connection between the northernmost bay of the south gallery, left, and the vaulting of the central chapel, right, looking northwest; this area is now covered by a wooden roof, as it undoubtedly was in the Byzantine period (June 2003)

west central dome when the funeral chapel was added (fig. 8). The three-stepped arch has an outermost layer of pinkish plaster, with crushed brick mixed into the mortar. Both of these areas had already been examined while the concrete roof was in place, but the relationships of the different components of the building are now considerably easier to comprehend.⁶

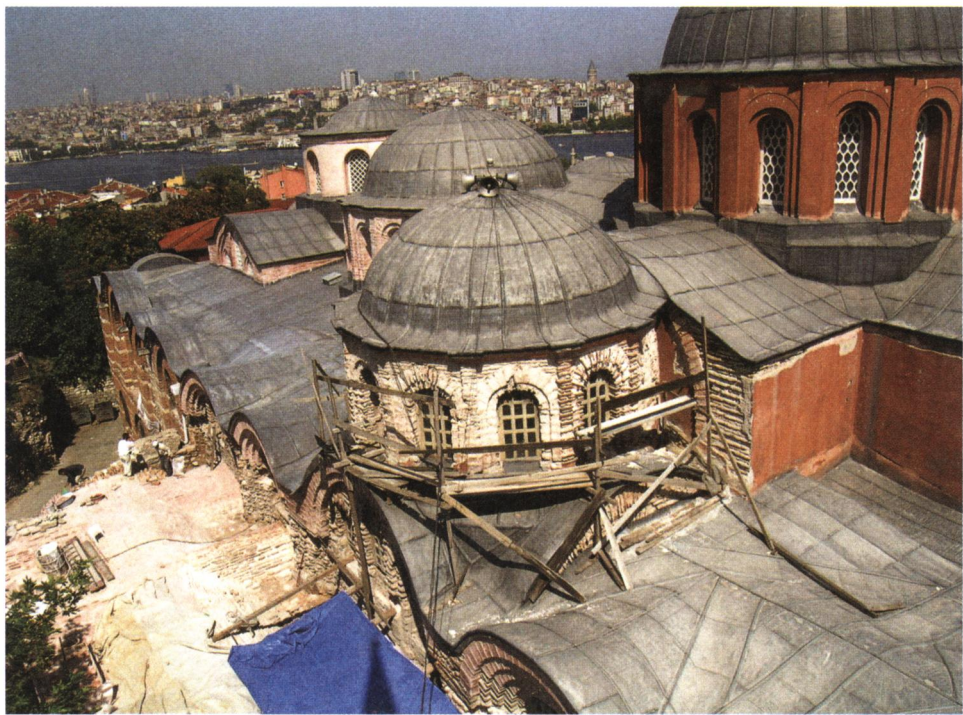
encountered a similarly heavy and intrusive concrete covering, as well as a similar history of damage and repair (fig. 9, left side). Once the concrete roof was removed, we mended a series of cracks in the vaults along the west façade of the building. Here the vaults had settled, probably compounded by earthquake movement, and the façade wall had rotated slightly outward. As in the past, the cracks were stitched together by inserting new bricks to join one side of the break to the other. We also regularized several areas of fill (at the corners of the vaults) to facilitate drainage. The north façade of the exonarthex was also repaired and its eaves regularized in preparation for the new roof. Before the lead sheeting was applied, the vaults were covered with a cap of lime mortar, and a low wooden roof was constructed over them, similar to the system applied to the north gallery roofs.

FIG. 9 Zeyrek Camii, view from the minaret, looking northeast, after the completion of the upper roofs and with work on the exonarthex roof (left) in progress (July 2004)

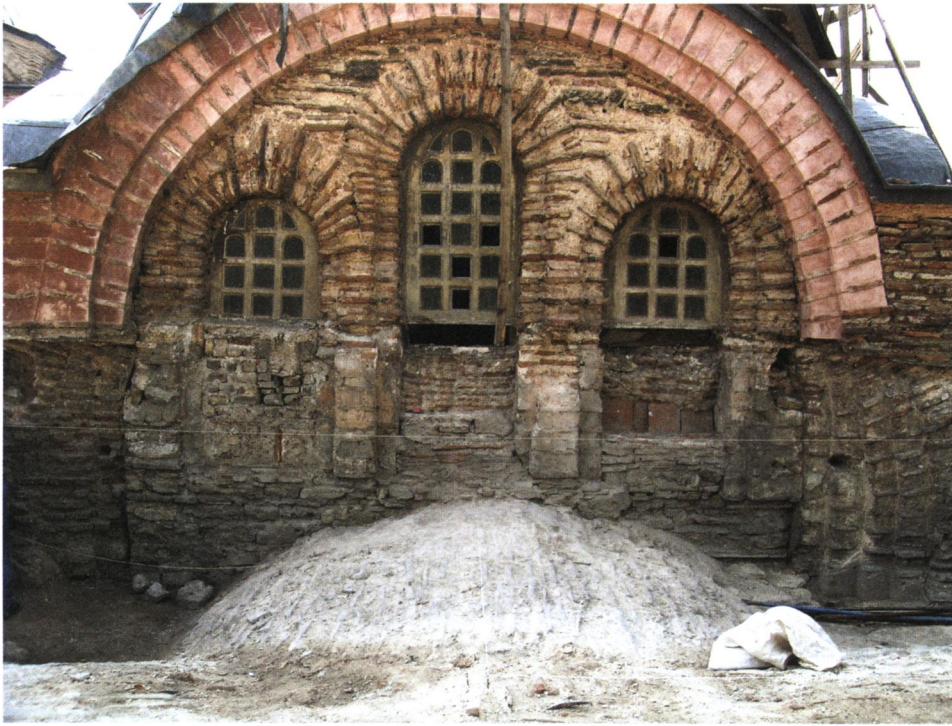
FIG. 11 Zeyrek Camii, central arcade of south gallery, looking east, after removal of concrete roof (July 2004)

that this was not part of the first phase, but that it was added only after the outer narthex was constructed. This change of design was clarified when the old concrete roof was removed and replaced in 2004 (fig. 11). The arcade of the central bay rises taller than the others, with its springing at a higher level. The pilasters to either side are quite broad, and the profiles of the central arcade are considerably simpler than the others, consisting of two setbacks where the others have four. At its impost, however, the details of the central arcade are considerably different and correspond to those of the other arcades. There the pilasters have multiple setbacks and preserve the springings of the original arcade, which was flattened and appears to have risen to the same height as the other façade arcades. Within the arcade are the setbacks for the original window openings.¹⁶ Just above the springings, the arcade was cut and marble imposts were inserted to support the construction of a higher arch. Just above the extrados of the exonarthex vaults, a line of pink plaster is still preserved, which extends into the window reveals. Built against this are masonry additions that correspond to the window mullions of the new arcade.

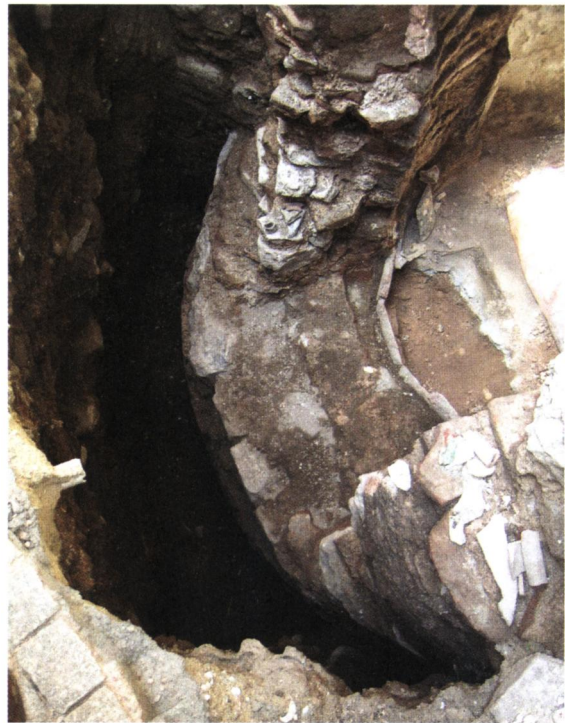
The windows of the north church pastophoria required heavy restoration as they had been altered after earthquake damage. Both were set asymmetrically and flare toward the interior, and the inner faces of the arches are cut by the curvatures of the apses. They were irregularly constructed from the beginning, with the diakonikon window rising ca. 68 cm higher than that of the prothesis. Moreover, the marble cornices at the imposts of the prothesis were set at different heights. The wall beneath the prothesis window had been cut back to floor level in the Ottoman period and required rebuilding. In cleaning the external surface for reconstructing the wall, we encountered the foundation of the prothesis at roughly the original floor level. The foundation is semicircular on the exterior, whereas the rising wall above it is polygonal (fig. 12).

FIG. 12 Zeyrek Camii, foundation of the prothesis of the north church looking down (June 2005)

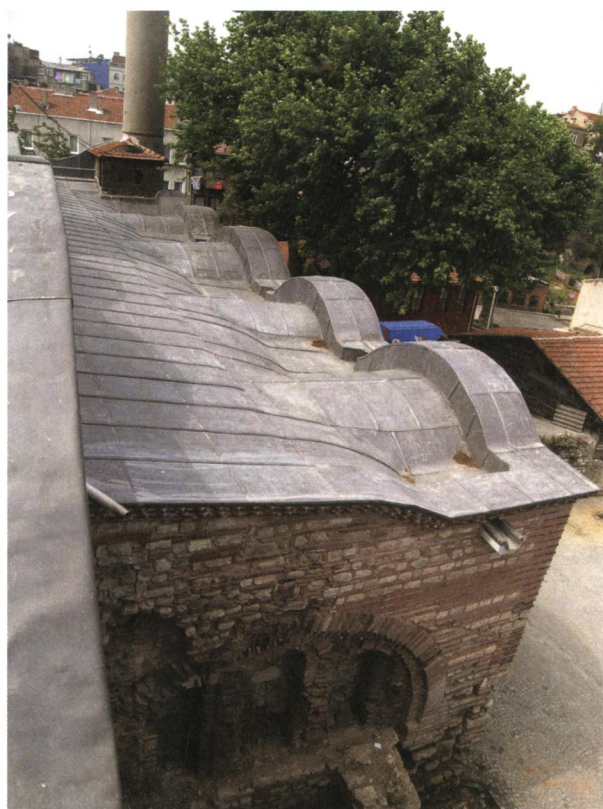
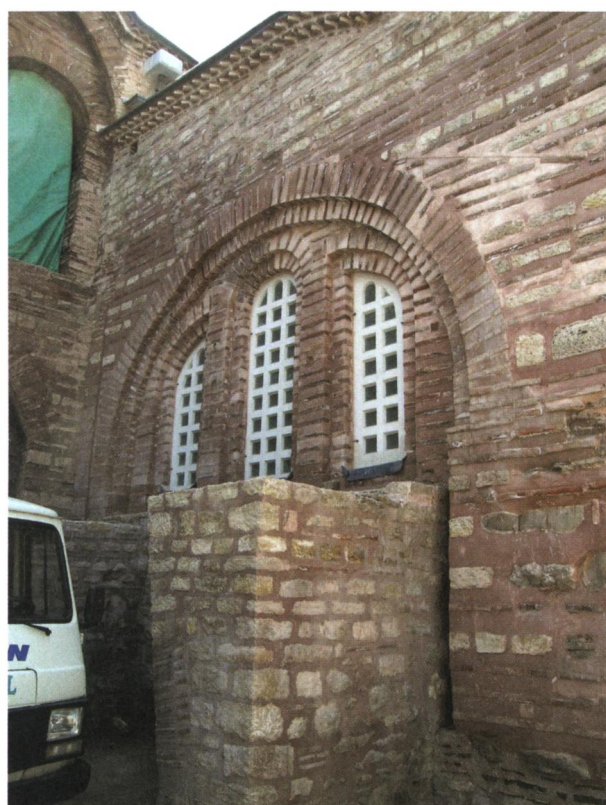
FIG. 13 (top) Zeyrek Camii, view toward the exonarthex, looking south, following completion of roof (June 2005)

FIG. 14 (bottom) Zeyrek Camii, north façade of the exonarthex, after completion of restoration (June 2006)

Beginning in 2004 and continuing into the subsequent season, the north façade of the exonarthex was restored (figs. 13–14). Although its interior surface remained well preserved, the exterior facing had been severely damaged, and the tripartite window had been blocked, probably when a late Ottoman house was built against it. With the cleaning of the surface, evidence began to appear for changes effected during the Byzantine period, including the raising of the roofline and strengthening with thick pilasters along the west façade. When the window lights were opened, evidence of the Byzantine fresco decoration also appeared.

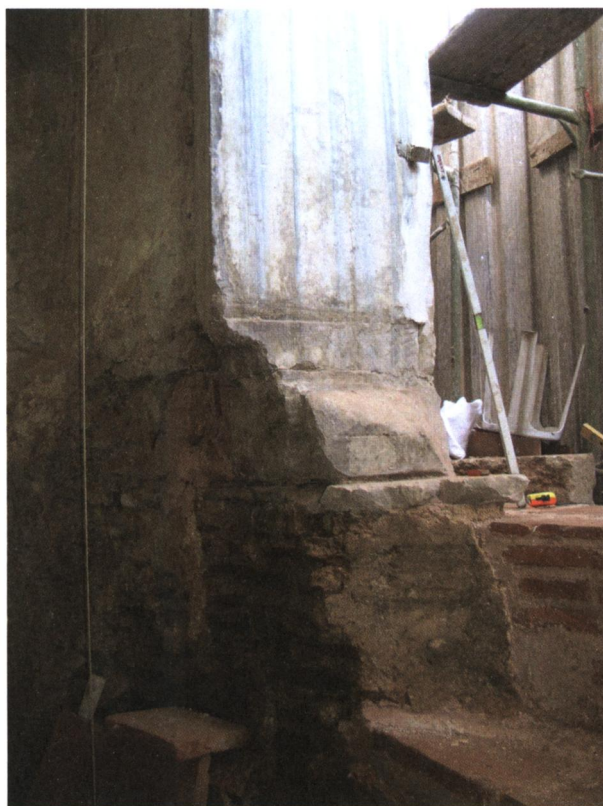
Within the apse of the north church, a bench had been cut into the lower wall surface, above which the wall has been hacked back and angled upward to the cornice. The bench itself seems to represent the line of the original wall surface. The lower and upper cornices do not follow the same curvature, and the lower cornice may have been reset when the wall was altered. Above the center of the bench, a semicircular niche was inserted between the window mullions, the bases of which were hacked back as the wall was altered (fig. 19). The window sill level was raised at the same time, with a new sill introduced just above the mullion bases. These changes seem to have been carried out in Byzantine times, as is indicated by the mortared surface, which was etched with lines when the mortar was damp, as

FIG. 19 Zeyrek Camii, north church, interior of apse showing Byzantine modifications: wall surface and mullion base cut back and niche inserted (July 2005)

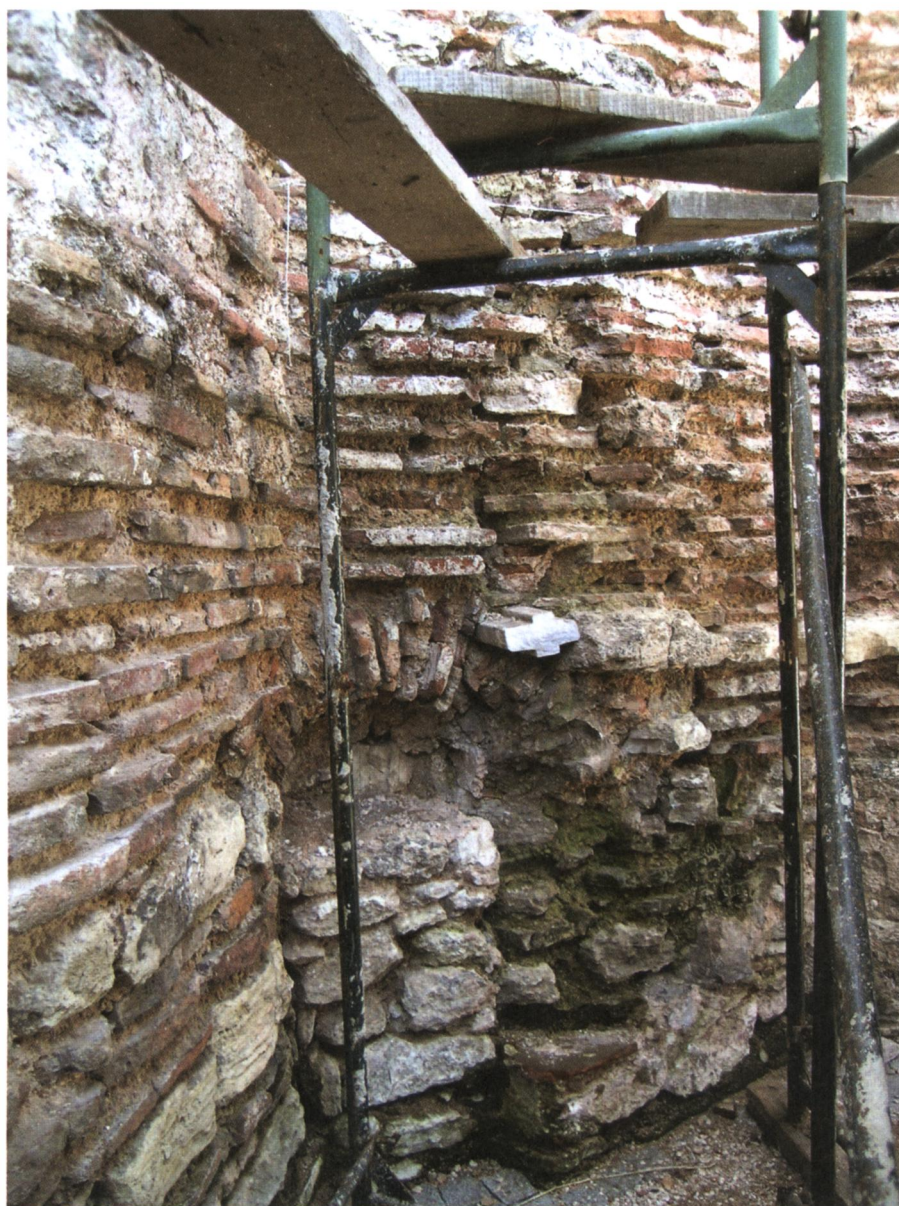
FIG. 24 Same, east façade, joint between middle (left) and north (right) churches, at blocked window (June 2003)
